LASER-INDUCED DAMAGE THRESHOLD (LIDT) MEASUREMENT REPORT

LIDT ISO S-ON-1 TEST PROCEDURE

SAMPLE: 25PR020-266

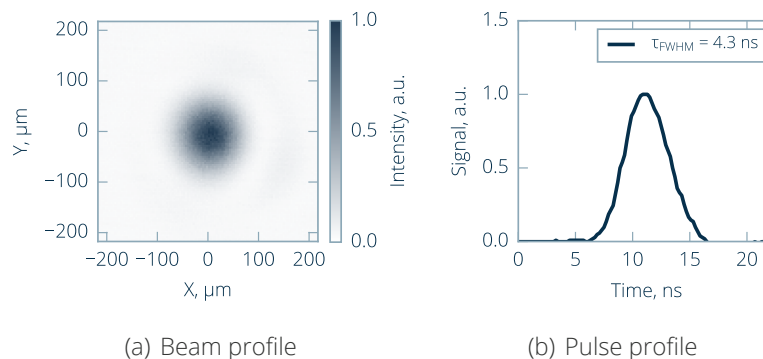
Type	Q-switched, seeded Nd:YAG (IL)
Manufacturer	InnoLas Laser II
Model	SpitLight Hybrid
Central wavelength	266.0 nm
Angle of incidence	45.0 Deg
Polarization state	Linear P
Pulse repetition frequency	100 Hz
Spatial beam profile in target plane	TEM00
Beam diameter in target plane ($1/e^2$)	$(214.3 \pm 4.7) \mu\text{m}$
Longitudinal pulse profile	Single longitudinal mode
Pulse duration (FWHM)	$(4.3 \pm 0.3) \text{ ns}$
Pulse to pulse energy stability (SD)	3.7 %

Figure 1. Laser parameters used for measurements.

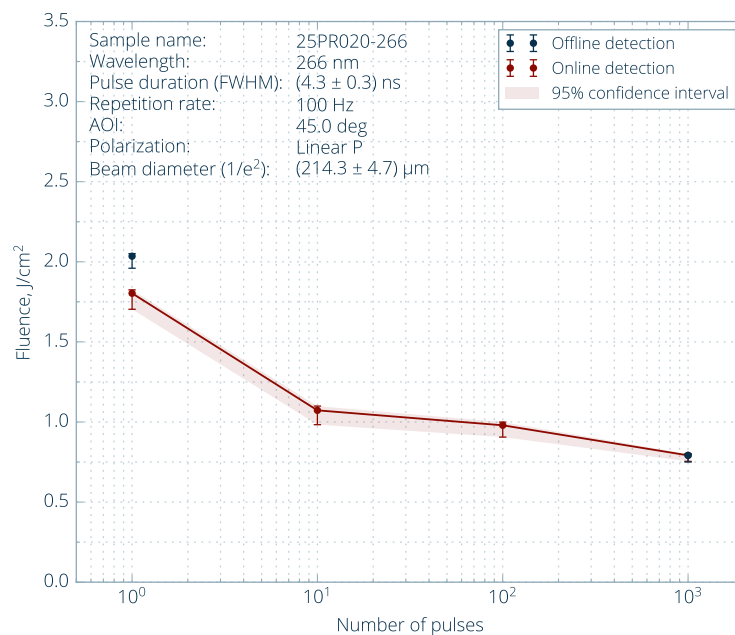
Test mode	Pulse duration	Threshold (Offline detection - microscopy)	Threshold (Online detection - scattering)
1-on-1	4.3 ns	$2.0349^{+0.0162}_{-0.0750} \text{ J/cm}^2$	$1.8035^{+0.0213}_{-0.0999} \text{ J/cm}^2$
	scaled to 10.0 ns	$3.1193^{+0.0248}_{-0.1150} \text{ J/cm}^2$	$2.7646^{+0.0327}_{-0.1532} \text{ J/cm}^2$
10-on-1	4.3 ns	-	$1.0727^{+0.0266}_{-0.0896} \text{ J/cm}^2$
	scaled to 10.0 ns	-	$1.6444^{+0.0407}_{-0.1374} \text{ J/cm}^2$
10^2 -on-1	4.3 ns	-	$0.9794^{+0.0200}_{-0.0738} \text{ J/cm}^2$
	scaled to 10.0 ns	-	$1.5013^{+0.0306}_{-0.1131} \text{ J/cm}^2$
10^3 -on-1	4.3 ns	$0.7917^{+0.0087}_{-0.0418} \text{ J/cm}^2$	$0.7916^{+0.0089}_{-0.0374} \text{ J/cm}^2$
	scaled to 10.0 ns	$1.2137^{+0.0134}_{-0.0641} \text{ J/cm}^2$	$1.2135^{+0.0136}_{-0.0573} \text{ J/cm}^2$

Figure 2. Characteristic damage curve.

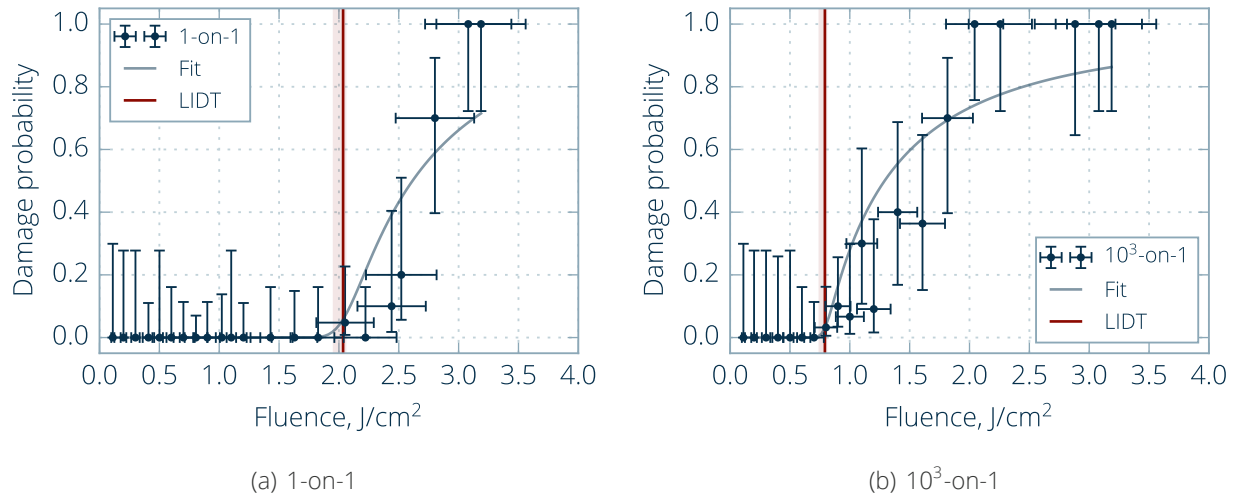
Figure 3. Damage probability plots.

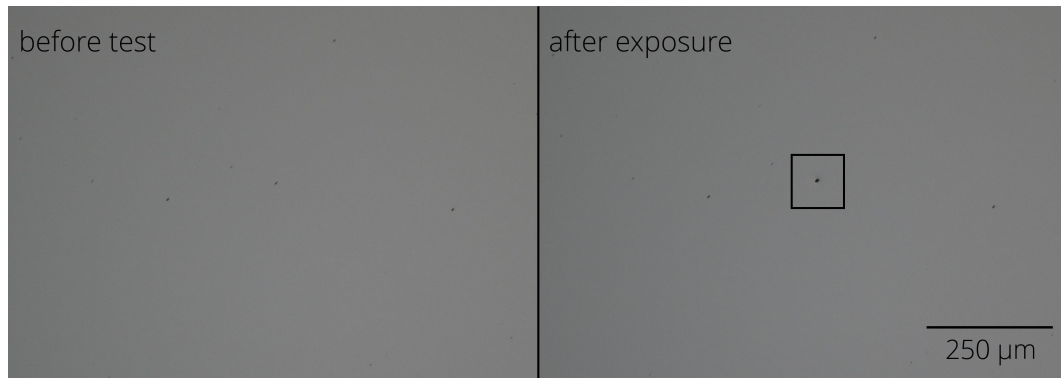
Figure 4. Typical damage morphology: fluence 0.800 J/cm^2 , damage after 1000 pulse(s).

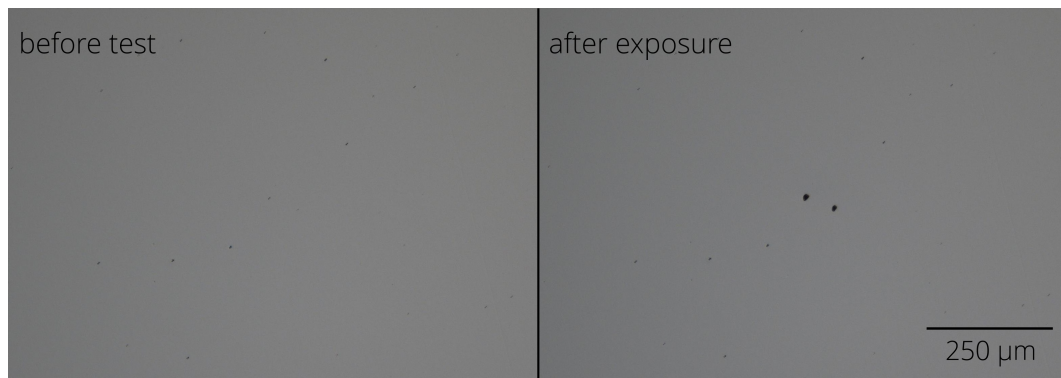
Figure 5. Typical damage morphology: fluence 1.65 J/cm^2 , damage after 110 pulse(s).

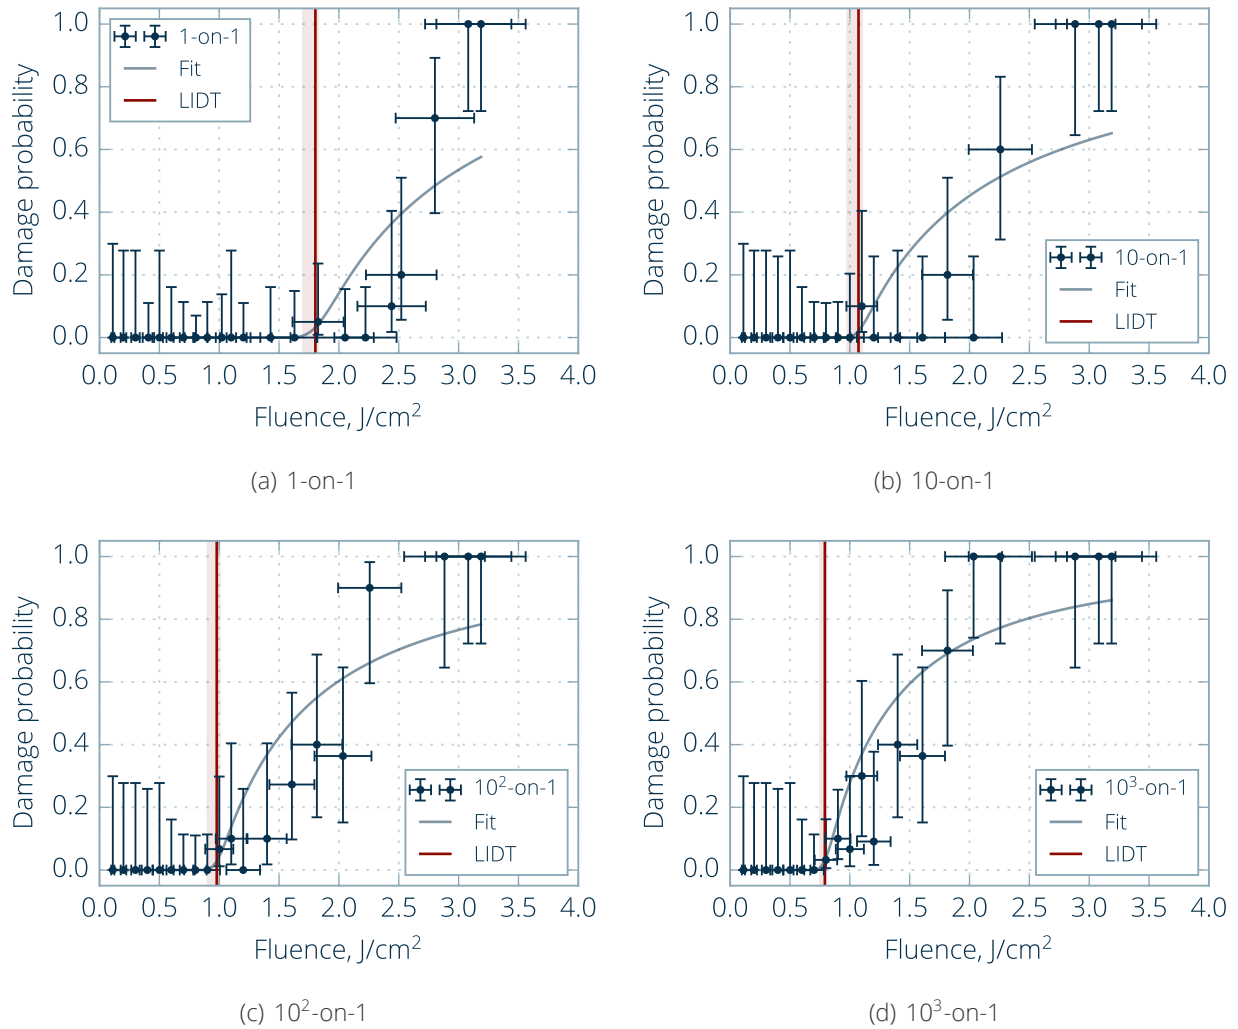
Figure 6. Damage probability plots.

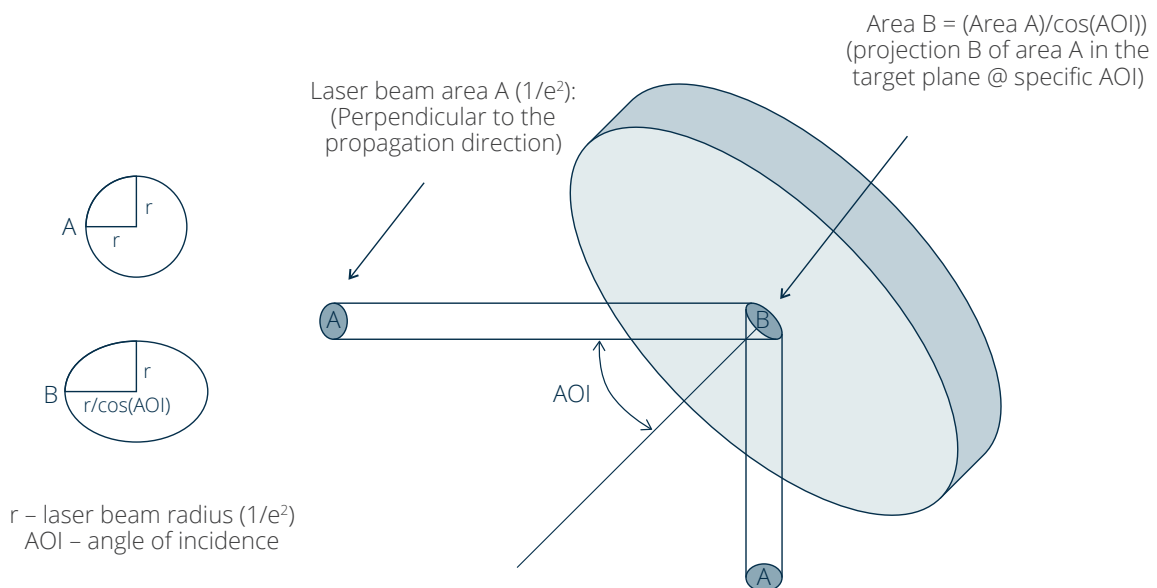
According to the ISO 21254-2:2011 standard, for spatial beam profiling perpendicular to the direction of beam propagation and angles of incidence differing from 0 degrees, the cosine of the angle of incidence is included in the calculation of the effective area, which leads to correct evaluation of laser fluence at different angles of incidence (Figure 7).

Figure 7. Oblique incidence.
